Flood Control Project Maintenance
2013 Structure Summary Report
Overall Unit and Item Ratings

DWR Sacramento Maintenance Yard

Flood Control Project Maintenance**Unit Cover Sheet****2013 Structure Inspection Results****DWR Sacramento Maintenance Yard**

**Flood Control Project Maintenance
Levee Inspections**

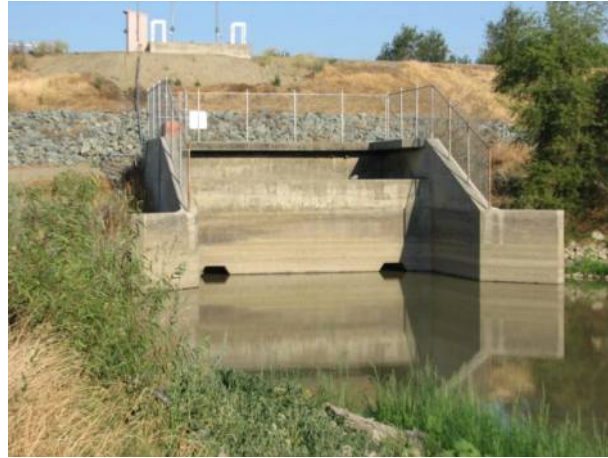
Levee Mile Report Line	24
Start Levee Mile	0.00
End Levee Mile	0.00
Location	Crown
Category	Structures
Item	Photo Documentation
A photo showing the outfall structure. Summer 2013	
johngw_t_20130703_027.JPG

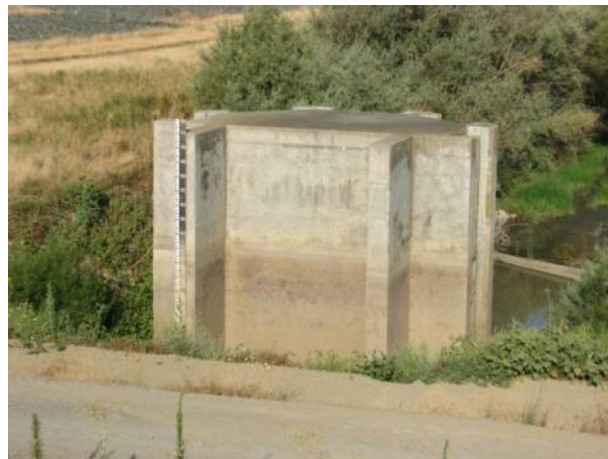
Levee Mile Report Line	24
Start Levee Mile	0.00
End Levee Mile	0.00
Location	Crown
Category	Structures
Item	Photo Documentation
A photo showing the intake structure. Summer 2013	
johngw_t_20130703_028.JPG

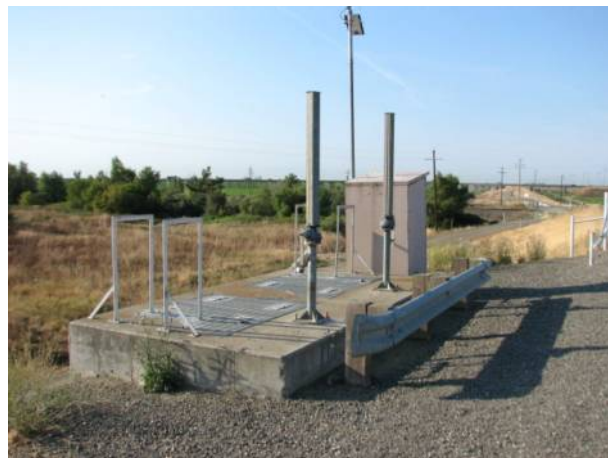
Levee Mile Report Line	24
Start Levee Mile	0.00
End Levee Mile	0.00
Location	Crown
Category	Structures
Item	Photo Documentation
A photo showing the control structure. Summer 2013	
johngw_t_20130703_029.JPG

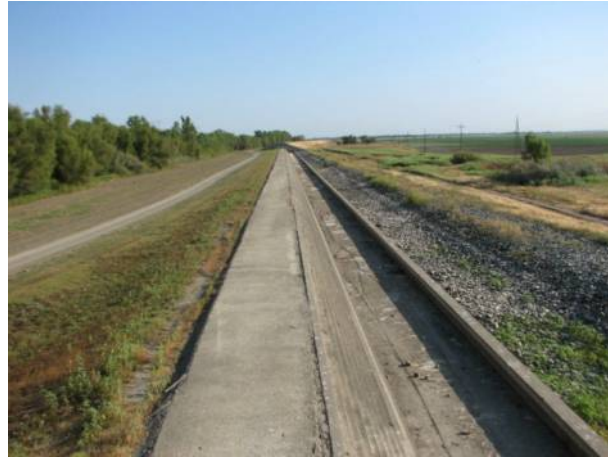
johngw_t_20130703_030.JPG

Looking north from the southend of the weir.
Summer 2013

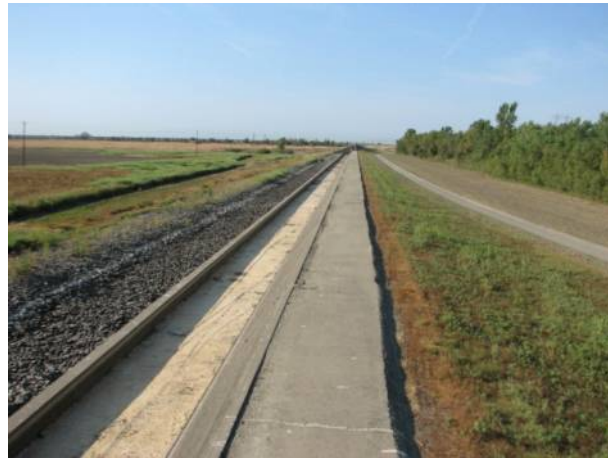
johngw_t_20130703_031.JPG

Looking south from the northend of the weir.
Summer 2013

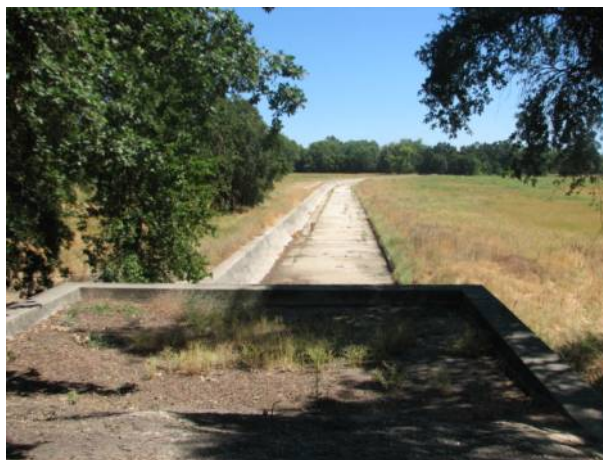
johngw_t_20130627_006.jpg

A view from the top at the westside. Summer 2013

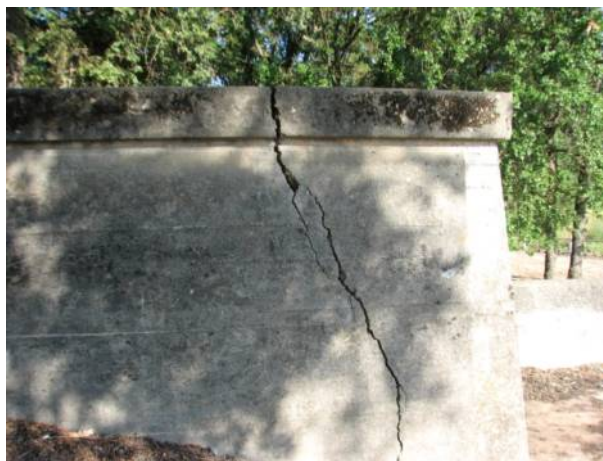
johngw_t_20130703_032.JPG

A crack runs top to bottom at the west end structure. Summer 2013

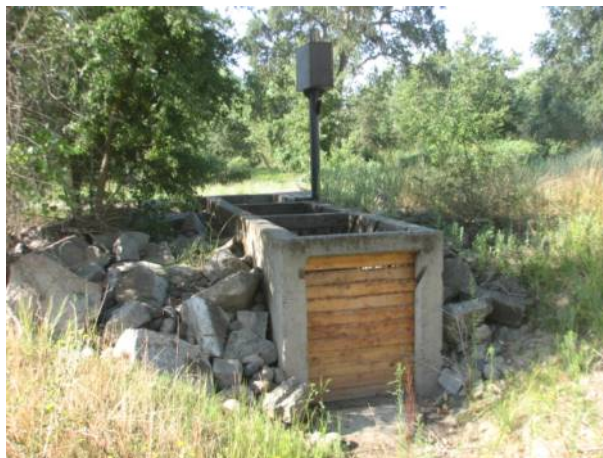
johngw_t_20130703_033.JPG

A view of the fish ladder a camera has been added. The broken concrete cross bar has been repaired. Summer 2013

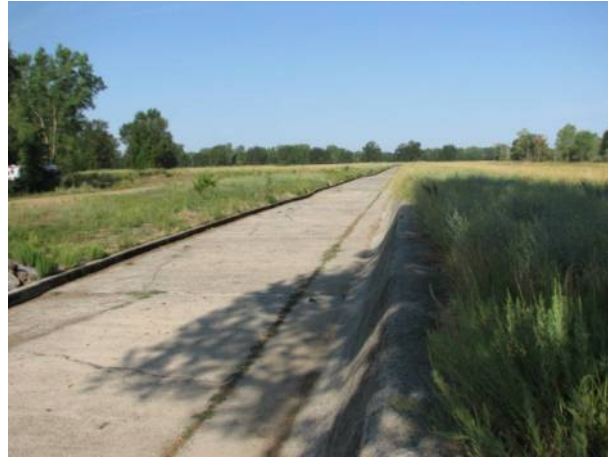
johngw_t_20130703_034.JPG

Looking to the west from the fish ladder. Summer 2013

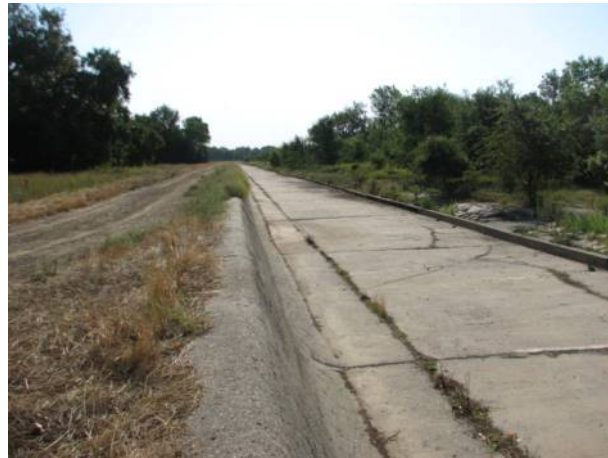
johngw_t_20130703_035.JPG

Looking to the east from the fish ladder. Summer 2013

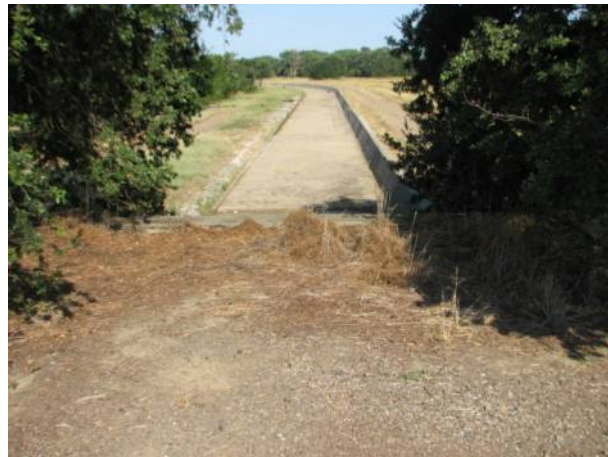
johngw_t_20130703_036.JPG

A view from the top at the east end of the weir. Summer 2013

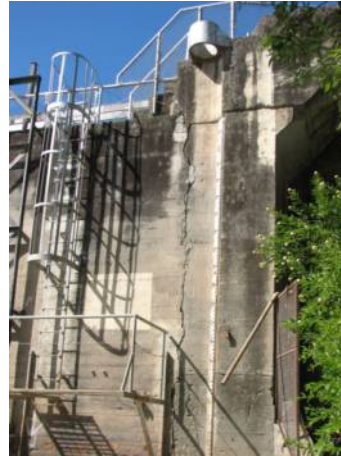
johngw_t_20130627_013.jpg

The crack at the north end of the structure has not changed from last year. Continue to monitor the crack and repair as necessary. The crack has been repaired

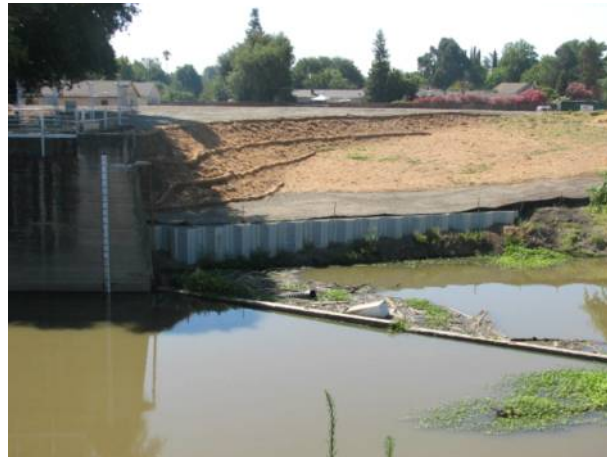
johngw_t_20130627_014.jpg

A new landing has been established for construction.

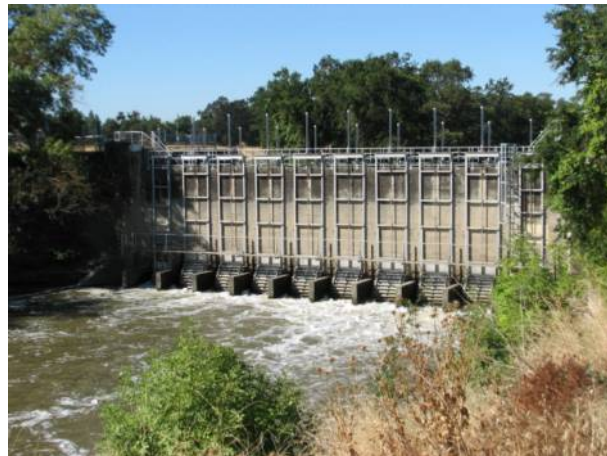
johngw_t_20130717_043.JPG

11	0.00	0.00	Structures	Flap Gates		A	Inspector Comments: The structure was up graded. There are new flap gates on the structure.	38.799560 ° -121.725530 °	38.799320 ° -121.724850 °	11
12	0.00	0.00	Structures	Sluice/Slide Gates		N	Inspector Comments: This item does not apply to this inspection.	38.799560 ° -121.725530 °	38.799320 ° -121.724850 °	12

The photo is from the Sacramento River side. New flap gates installed. Summer 2013

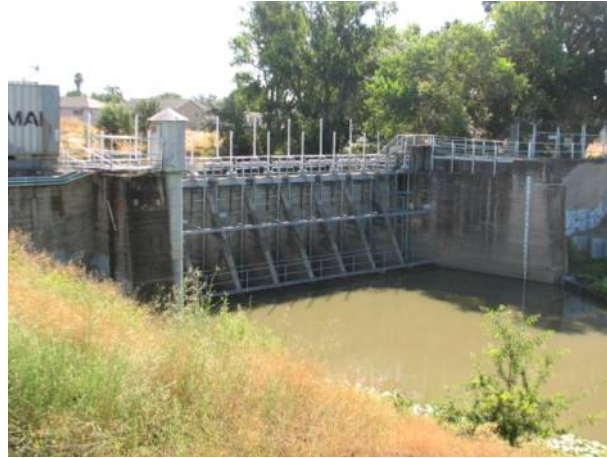
Levee Mile Report Line	1
Start Levee Mile	0.00
End Levee Mile	0.00
Location	
Category	Structures
Item	Photo Documentation
The photo is taken from the inlet side of the structure. Summer 2013	
john_gw_t_20130717_044.JPG

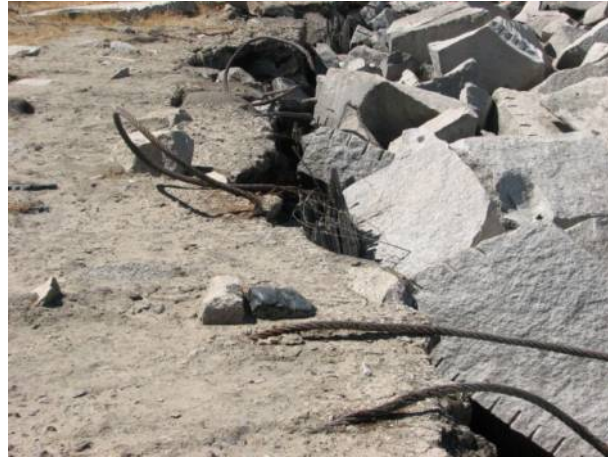
johngw_t_20130627_017.jpg

Cable sticking out from the dam and could be a hazard.

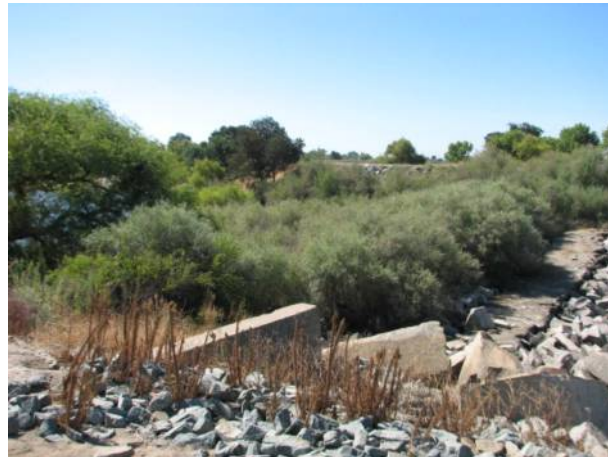
johngw_t_20130722_045.JPG

A photo of the sandbar willows in front of the structure. Summer 2013

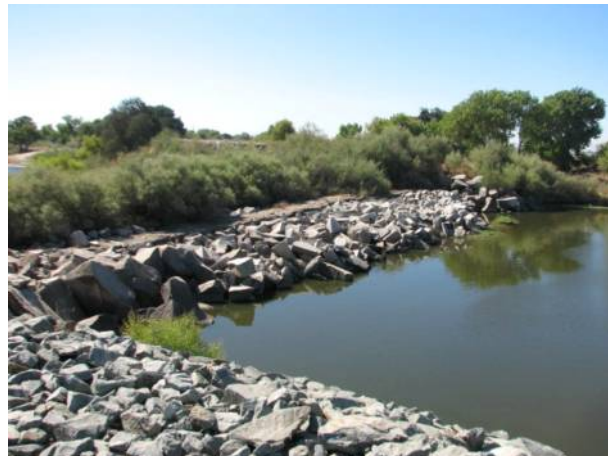
johngw_t_20130722_046.JPG

A photo of the backside of the structure Summer 2013

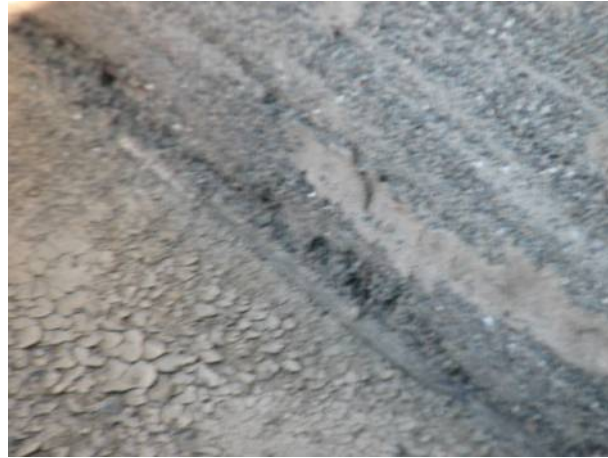
johngw_t_20130716_037.JPG

LMR No.	Levee Mile		Category	Item	Location *	Rating **	Action/Comment	GPS Latitude/Longitude		Issue No.
	Start	End						Start	End	Photo
15	0.00	0.00	Structures	Concrete Surfaces	CR	A	Inspector Comments: Spalling, scaling, and open cracking present, but the immediate integrity or performance of the structure is not threatened. Reinforcing steel is exposed. Sacramento Maintenance has done a great job in repairing the concrete surfaces. Some minor repairs are left to be done (see photos).	38.607120 ° -121.560100 °	38.607120 ° -121.560100 °	15
16	0.00	0.00	Structures	Concrete Tilting / Settlement	CR	N	Inspector Comments: This item does not apply to this inspection.	38.607120 ° -121.560100 °	38.607120 ° -121.560100 °	16
17	0.00	0.00	Structures	Concrete Foundations	CR	A	Inspector Comments: No scouring / erosion or undermining near the structure.	38.607120 ° -121.560100 °	38.607120 ° -121.560100 °	17

(Bay 11) Minor damage on concrete surface.
Summer 2013

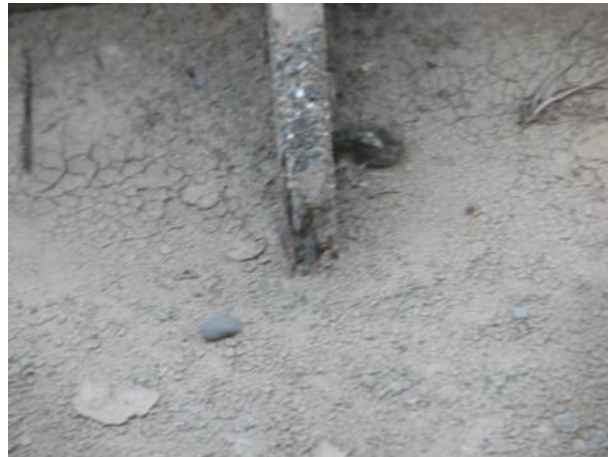
johngw_t_20130716_038.JPG

(Bay 3) Minor damage some rebar
exposed. Summer 2013

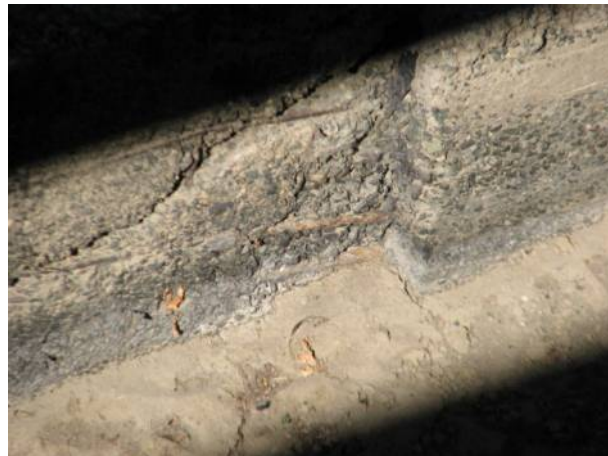
johngw_t_20130716_039.JPG

(Bay 1) Minor damage on concrete surface some
rebar exposed. Summer 2013

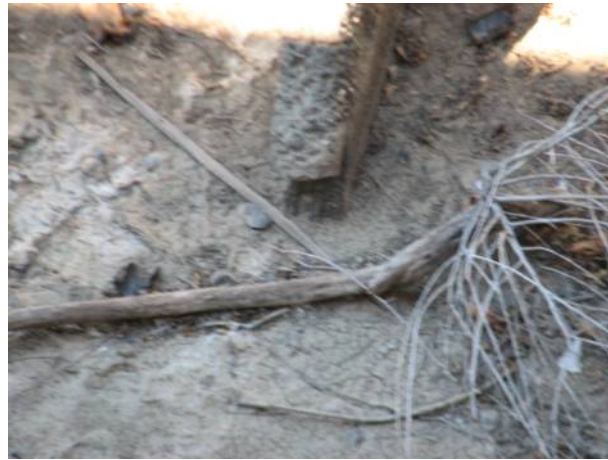
johngw_t_20130716_040.JPG

(Bay 1) Minor damage on concrete surface some rebar exposed. Summer 2013

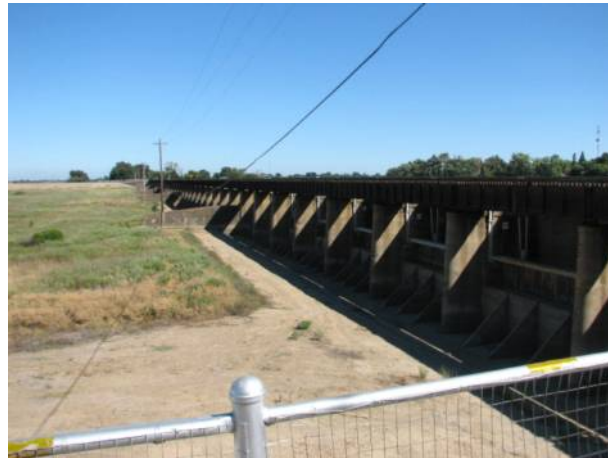
johngw_t_20130716_041.JPG

A view from the south side of the weir. Summer 2013

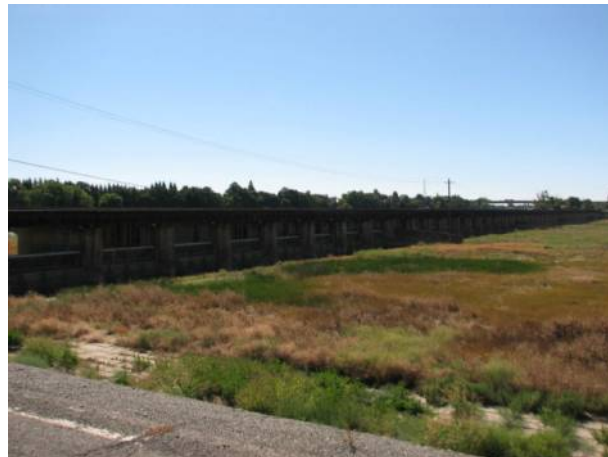
johngw_t_20130716_042.JPG

A view from the north side of the weir. Summer 2013
